DEPARTMENT OF TRANSPORTATION

Quality Assurance and Source Inspection

Contract #: 04-0120F4Cty: SF/ALA Rte: 80 PM: 13.2/13.9File #: 69.28**WELDING INSPECTION REPORT****Resident Engineer:**Siegenthaler, Peter**Address:** 333 Burma Road**City:** Oakland, CA 94607**Report No:** WIR-017417**Date Inspected:** 13-Oct-2010**Project Name:** SAS Superstructure**OSM Arrival Time:** 700**Prime Contractor:** American Bridge/Fluor Enterprises, a JV**OSM Departure Time:** 1900**Contractor:** Zhenhua Port Machinery Company, Ltd (ZPMC), Changxing Island **Location:** Shanghai, China**CWI Name:** Lv Li Qing**CWI Present:** Yes No**Inspected CWI report:** Yes No N/A**Rod Oven in Use:** Yes No N/A**Electrode to specification:** Yes No N/A**Weld Procedures Followed:** Yes No N/A**Qualified Welders:** Yes No N/A**Verified Joint Fit-up:** Yes No N/A**Approved Drawings:** Yes No N/A**Approved WPS:** Yes No N/A**Delayed / Cancelled:** Yes No N/A**Bridge No:** 34-0006**Component:** OBG**Summary of Items Observed:**

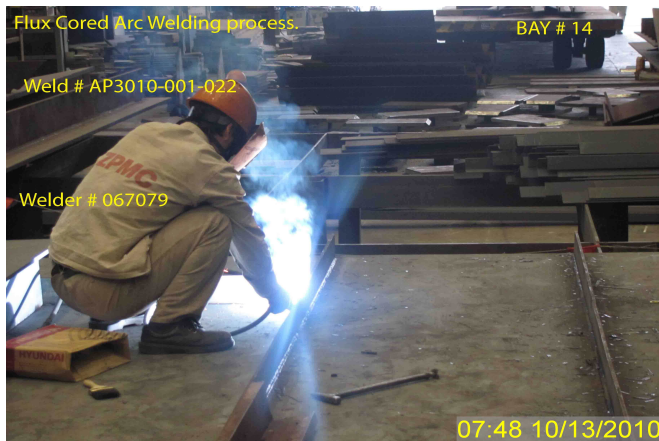
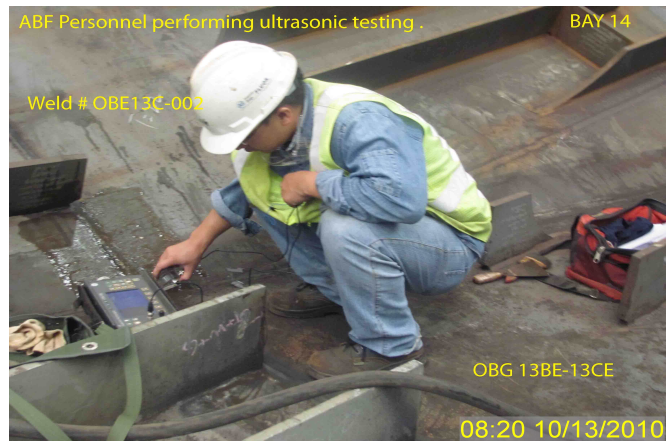
This Quality Assurance (QA) Inspector observed ZPMC qualified welder 068994 performing the Flux cored Arc Welding process on weld 019 located at PCMK W5-SB1-014. ZPMC QC Mr. Guo Pan was monitoring this welding operation. The welding variables recorded by QC appeared to comply with WPS-B-T-2231-B-u2-f.

Unless otherwise noted, all work observed on this date appeared to generally comply with applicable contract documents.
